Technical Memorandum

I-290

Preliminary Engineering

Existing Americans with Disabilities Act (ADA) Accessibility

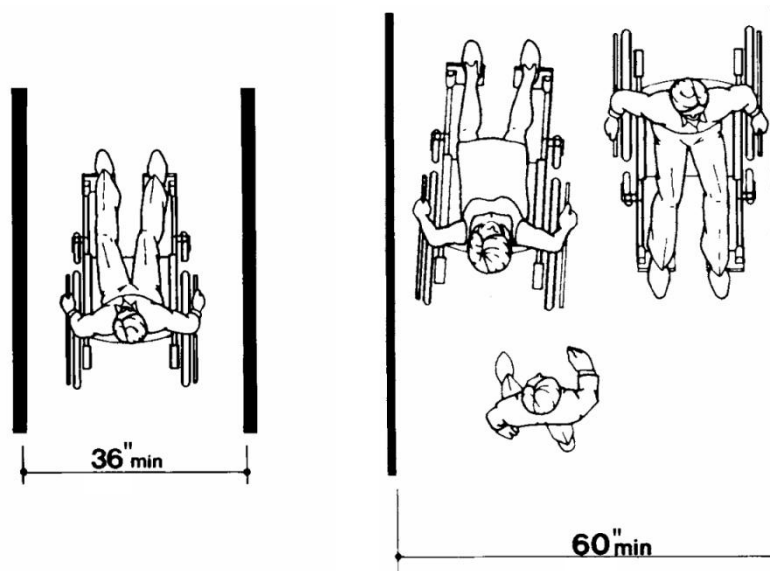
Figure 2-1 – Typical ADA Accessible Routes

The existing sidewalks and curb ramps are required to meet the ADA Accessibility Guidelines. These guidelines have standards for many different design aspects such as building and parking design. The standards that were used to analyze the existing sidewalk conditions in this study were those for accessible routes (See **Figure 2-1** and ADAAG 4.3), curb ramps (See Figure 2-2 and ADAAG 4.7), and ramps (ADAAG 4.8). These requirements specify the locations, slopes, widths, and changes in levels of the sidewalks and curb ramps along with additional requirements for the detectable warnings, islands, adjacent gutters, and adjacent roadways.

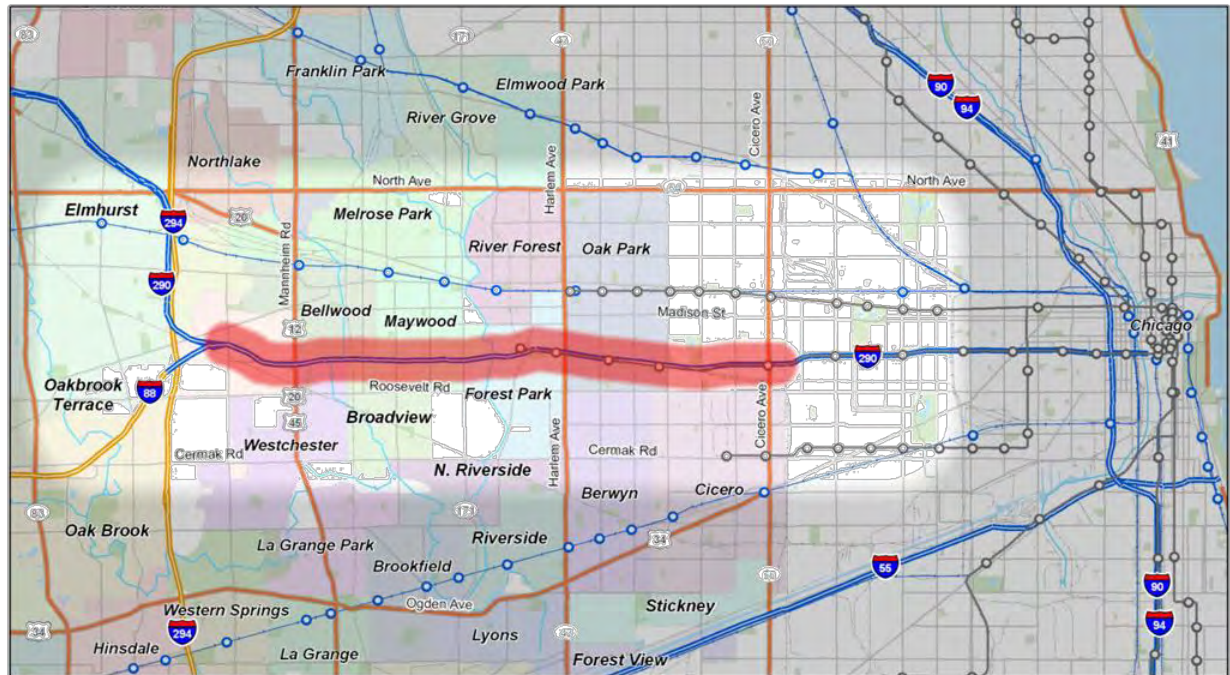
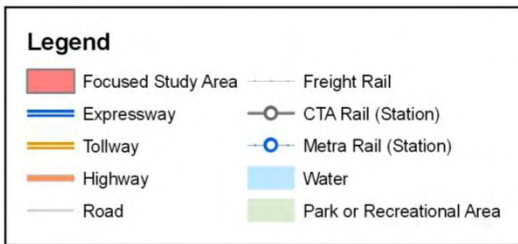
Figure 2-3 – Study Area Map

The existing sidewalks and curb ramps along the crossroads and frontage roads within the focused study area (**Figure 2-3**) were reviewed for compliance with the current ADA Standards. The crossroads were reviewed from the second intersection to the south of I-290 to the second intersection to the north of I-290, and the frontage roads adjacent to I-290 were reviewed. This includes their sidewalks and curb ramps at each intersection. Deficient curb ramps at frontage and cross road sidewalk intersections with alleys and driveways were also reviewed. A photo log and data sheet of the curbs and sidewalks reviewed can be found in the Appendix.

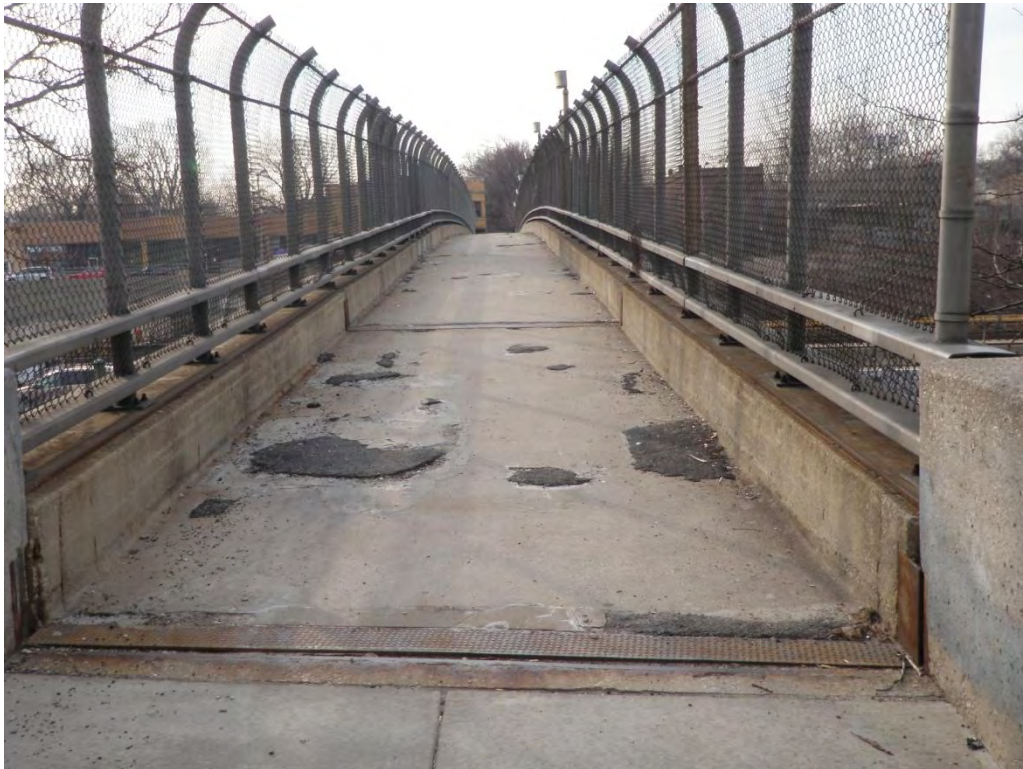
Figure 3-1 – Existing Home Avenue pedestrian bridge over I-290

There are two non-motorized, shared-use crossings of I-290 in the study area; at Home Ave. (**Figure 3-1**) in Oak Park, and at Lavergne Ave. (**Figure 3-2**) in Chicago. The existing bridge decks of both structures are in a deteriorated condition.

The sidewalk approach ramps for the Home Ave. crossing currently meet ADA standards and are in good condition. The sidewalk ramps for the Lavergne Ave. pedestrian crossing do not meet ADA standards because their slopes are too steep and do not have the required level landings and handrails.

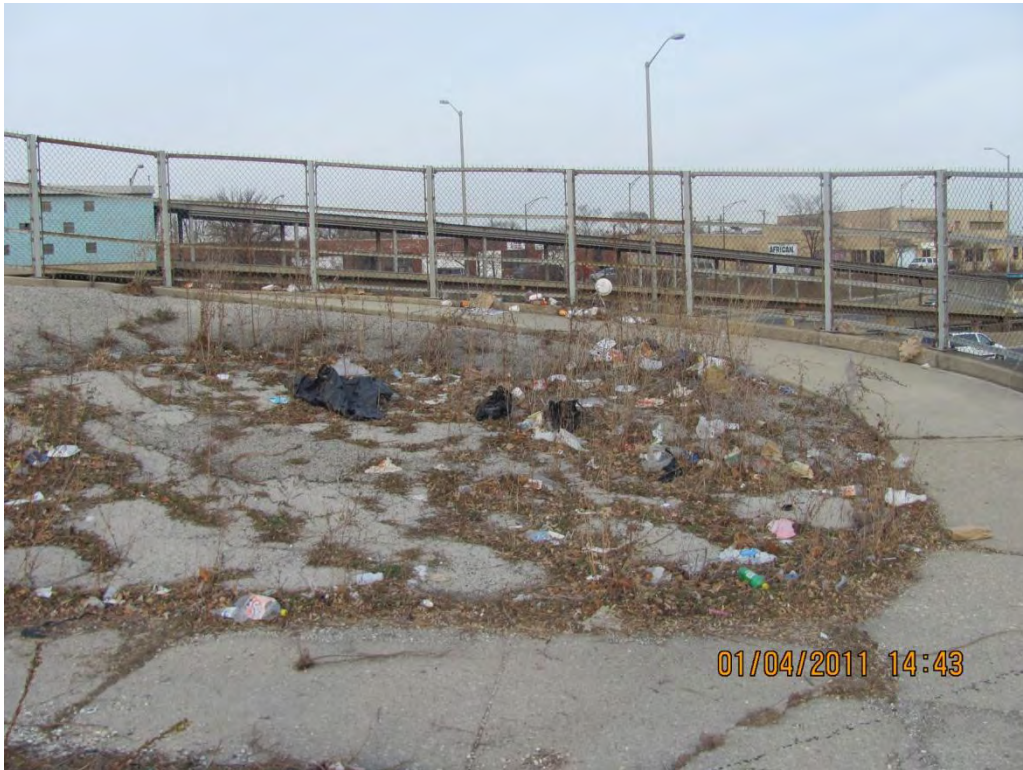
Figure 3-2 – Existing Lavergne Avenue pedestrian bridge over I-290

The crossing at Lavergne Ave./I-290 is also considered a high pedestrian traffic generator due to the existing train station access ramp connected to the crossing. **Table 3-4** summarizes the accessibility findings of the non-motorized pedestrian crossings.

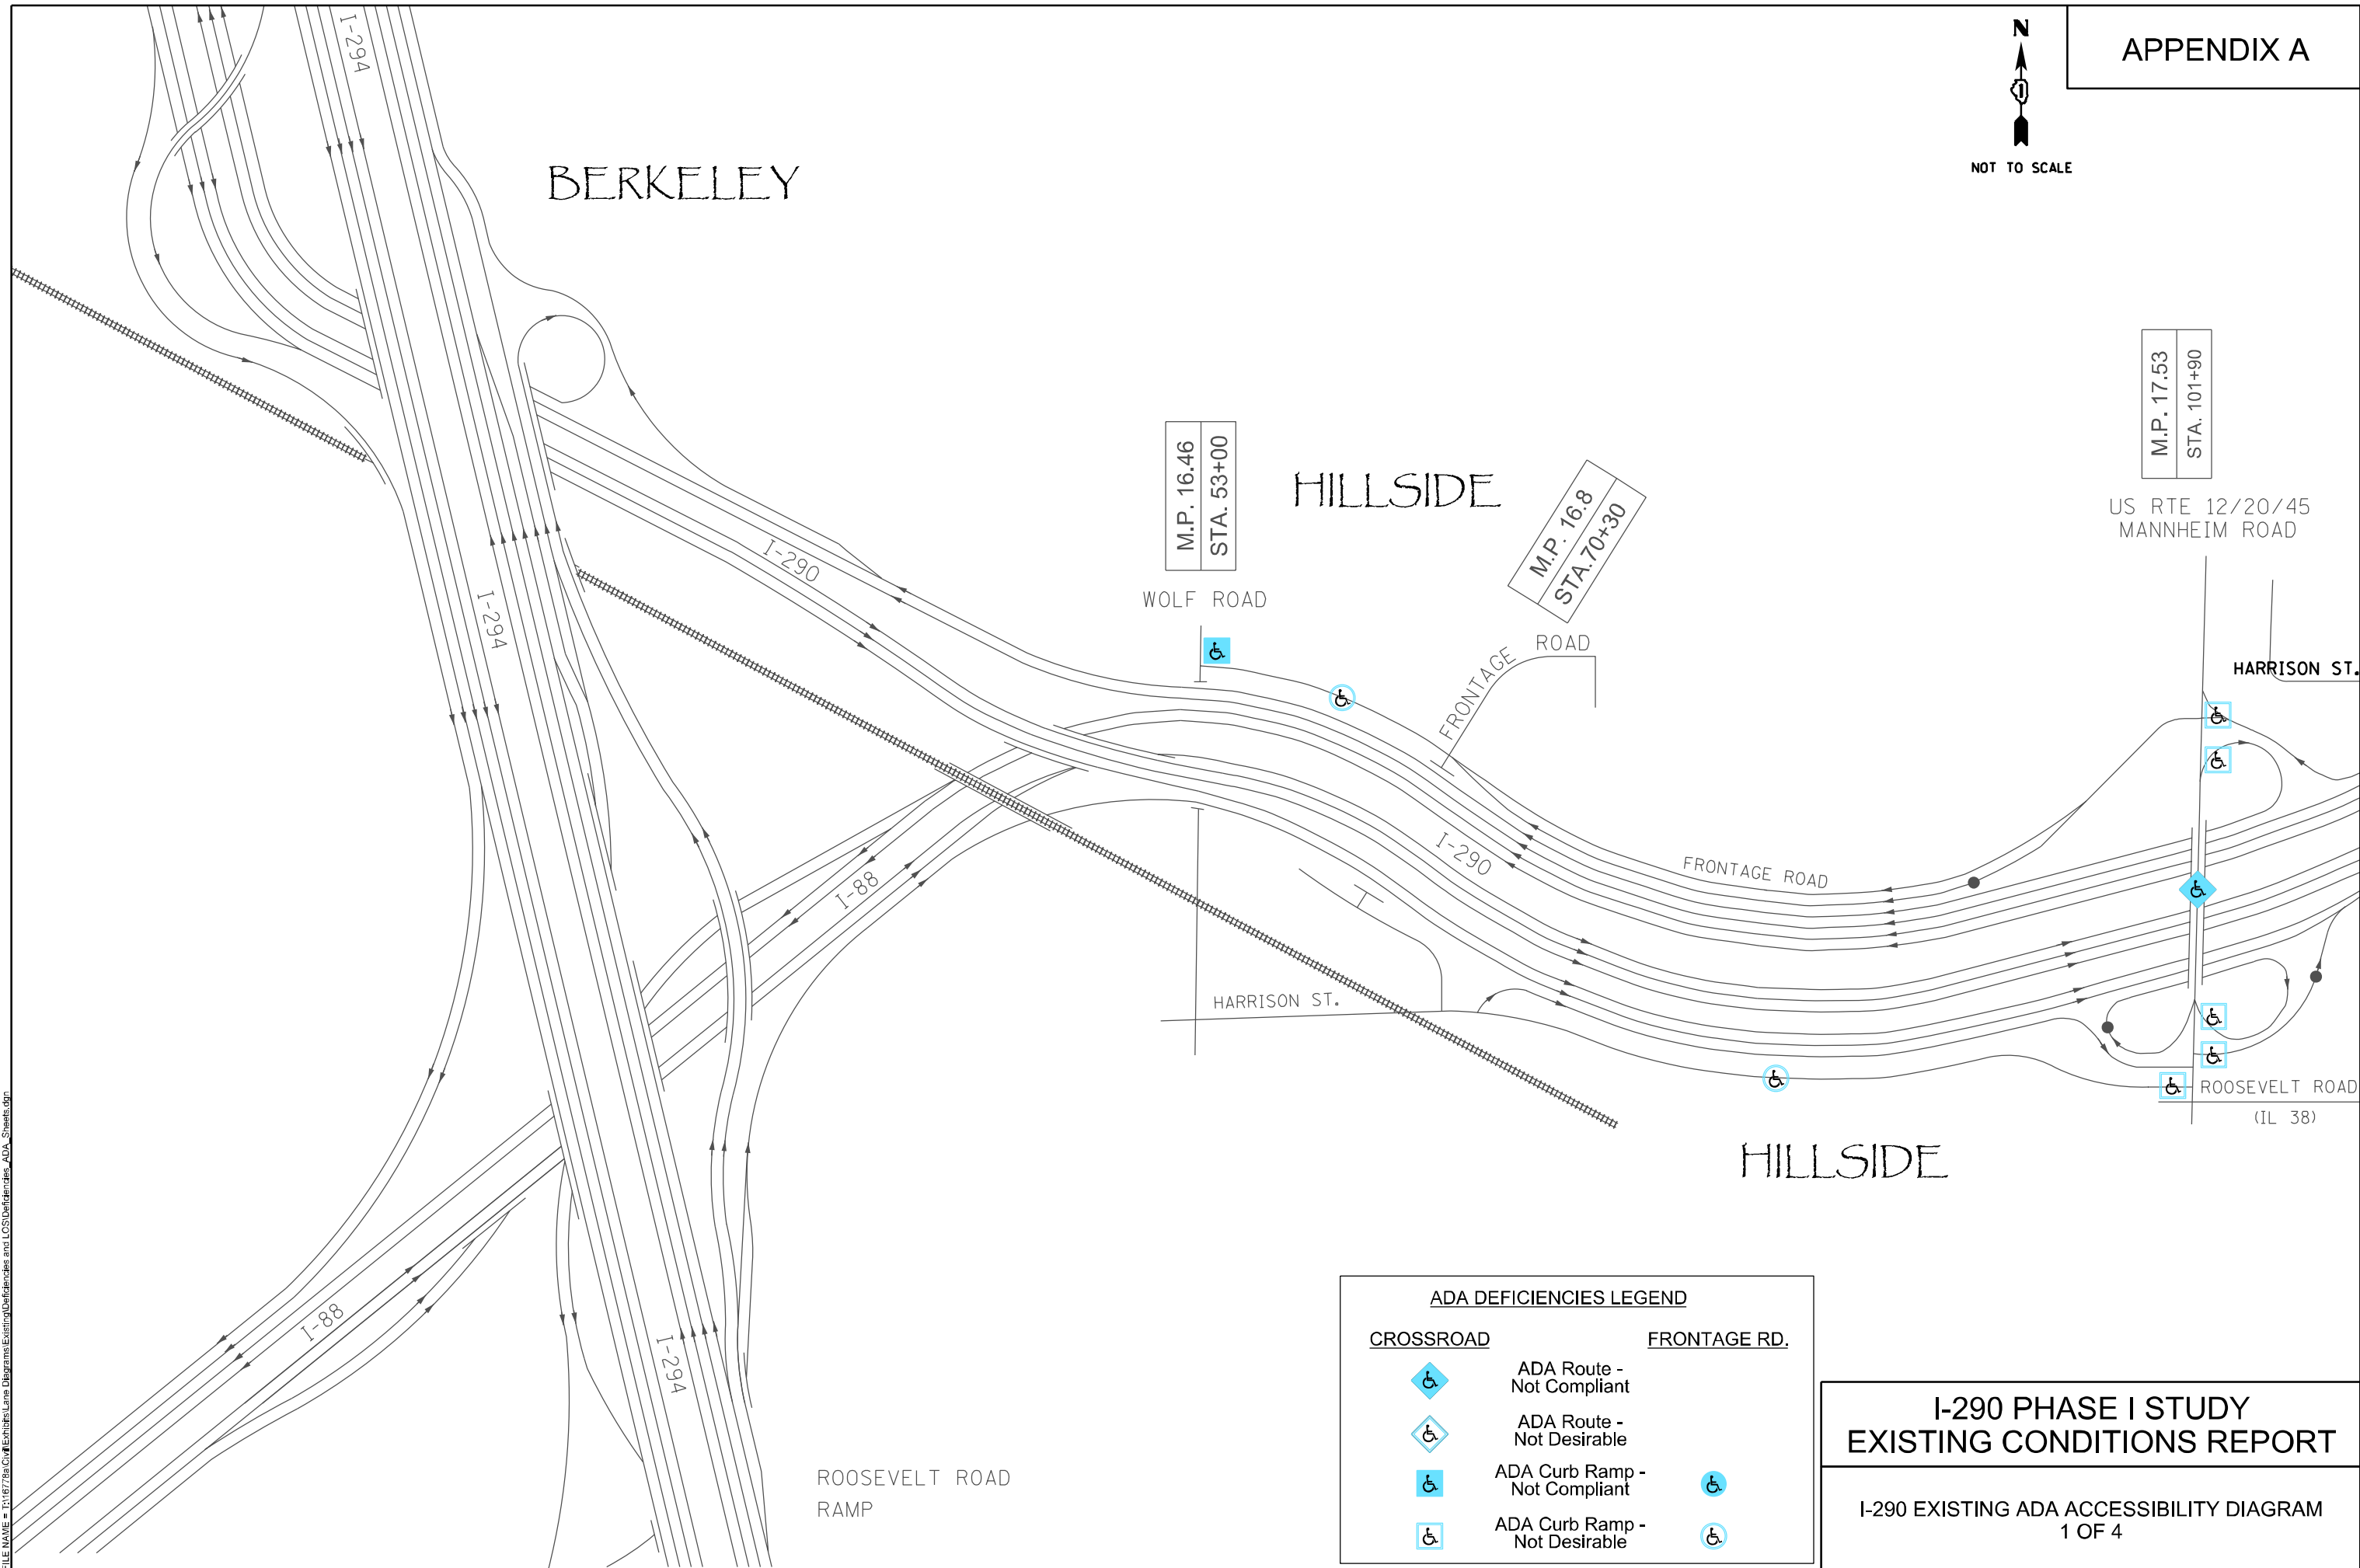
I-290 Existing ADA Accessibility Diagram

ADA DEFICIENCIES LEGEND	
CROSSROAD	FRONTAGE RD.
	ADA Route - Not Compliant
	ADA Route - Not Desirable
	ADA Curb Ramp - Not Compliant
	ADA Curb Ramp - Not Desirable

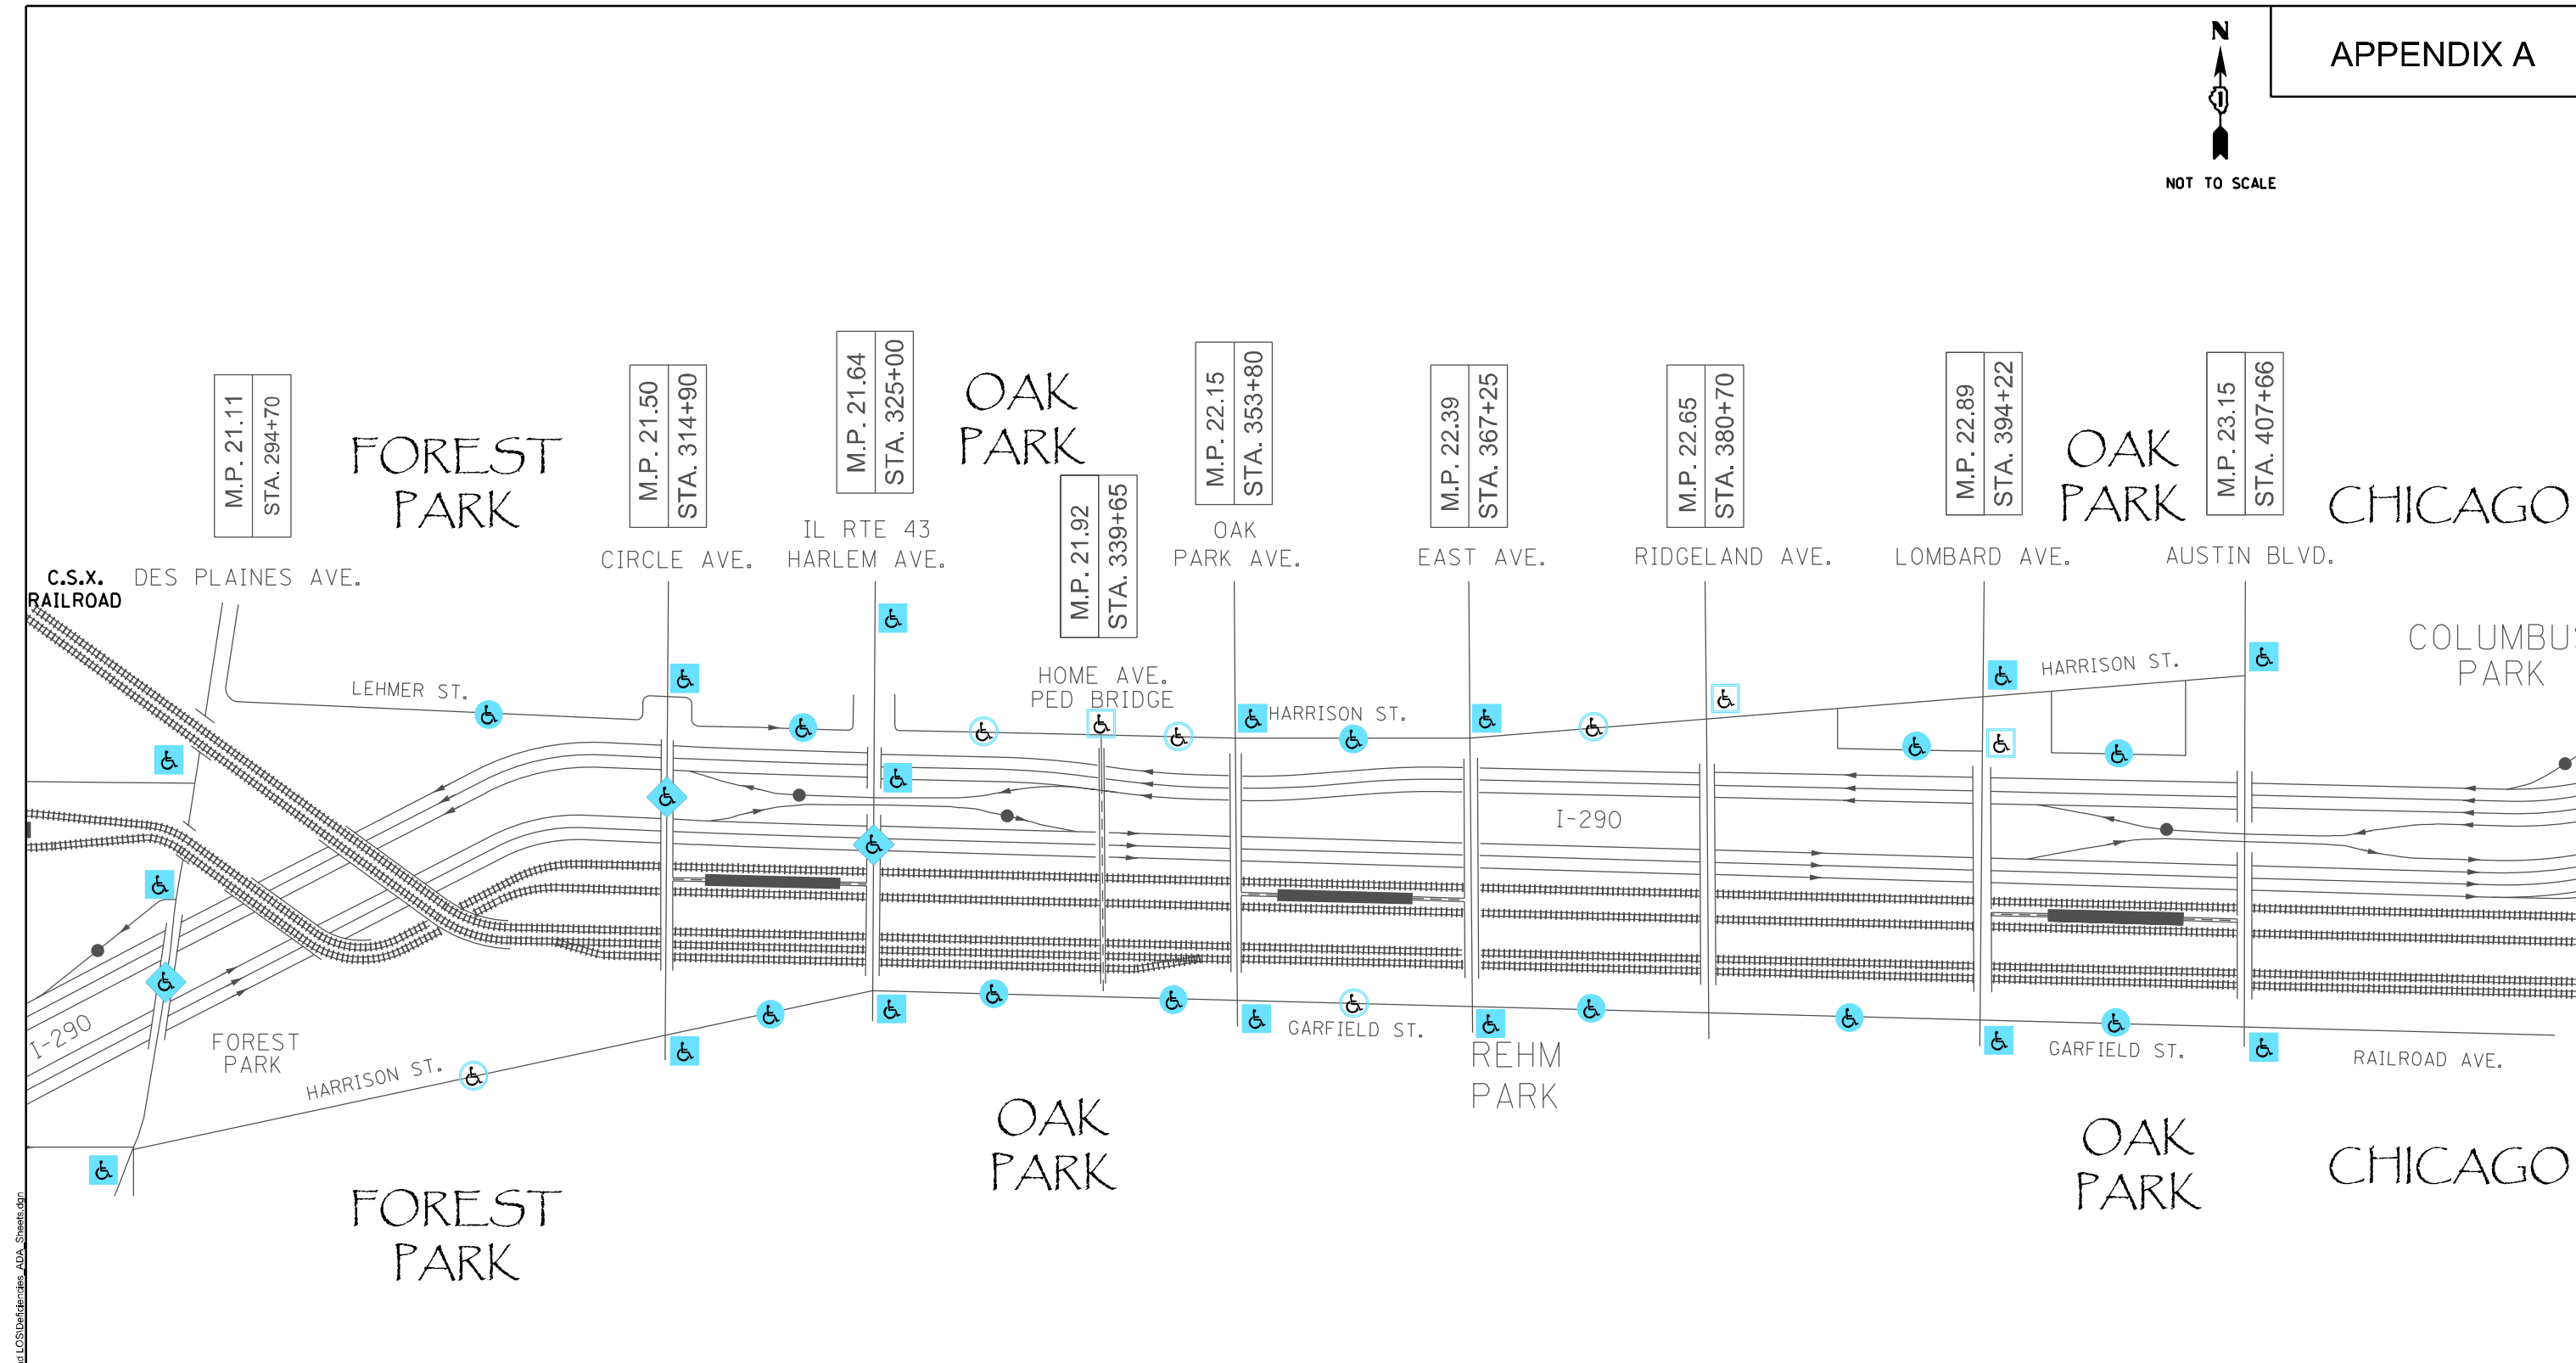
I-290 EXISTING ADA ACCESSIBILITY DIAGRAM
2 OF 4

ADA DEFICIENCIES LEGEND	
CROSSROAD	FRONTAGE RD.
	ADA Route - Not Compliant
	ADA Route - Not Desirable
	ADA Curb Ramp - Not Compliant
	ADA Curb Ramp - Not Desirable

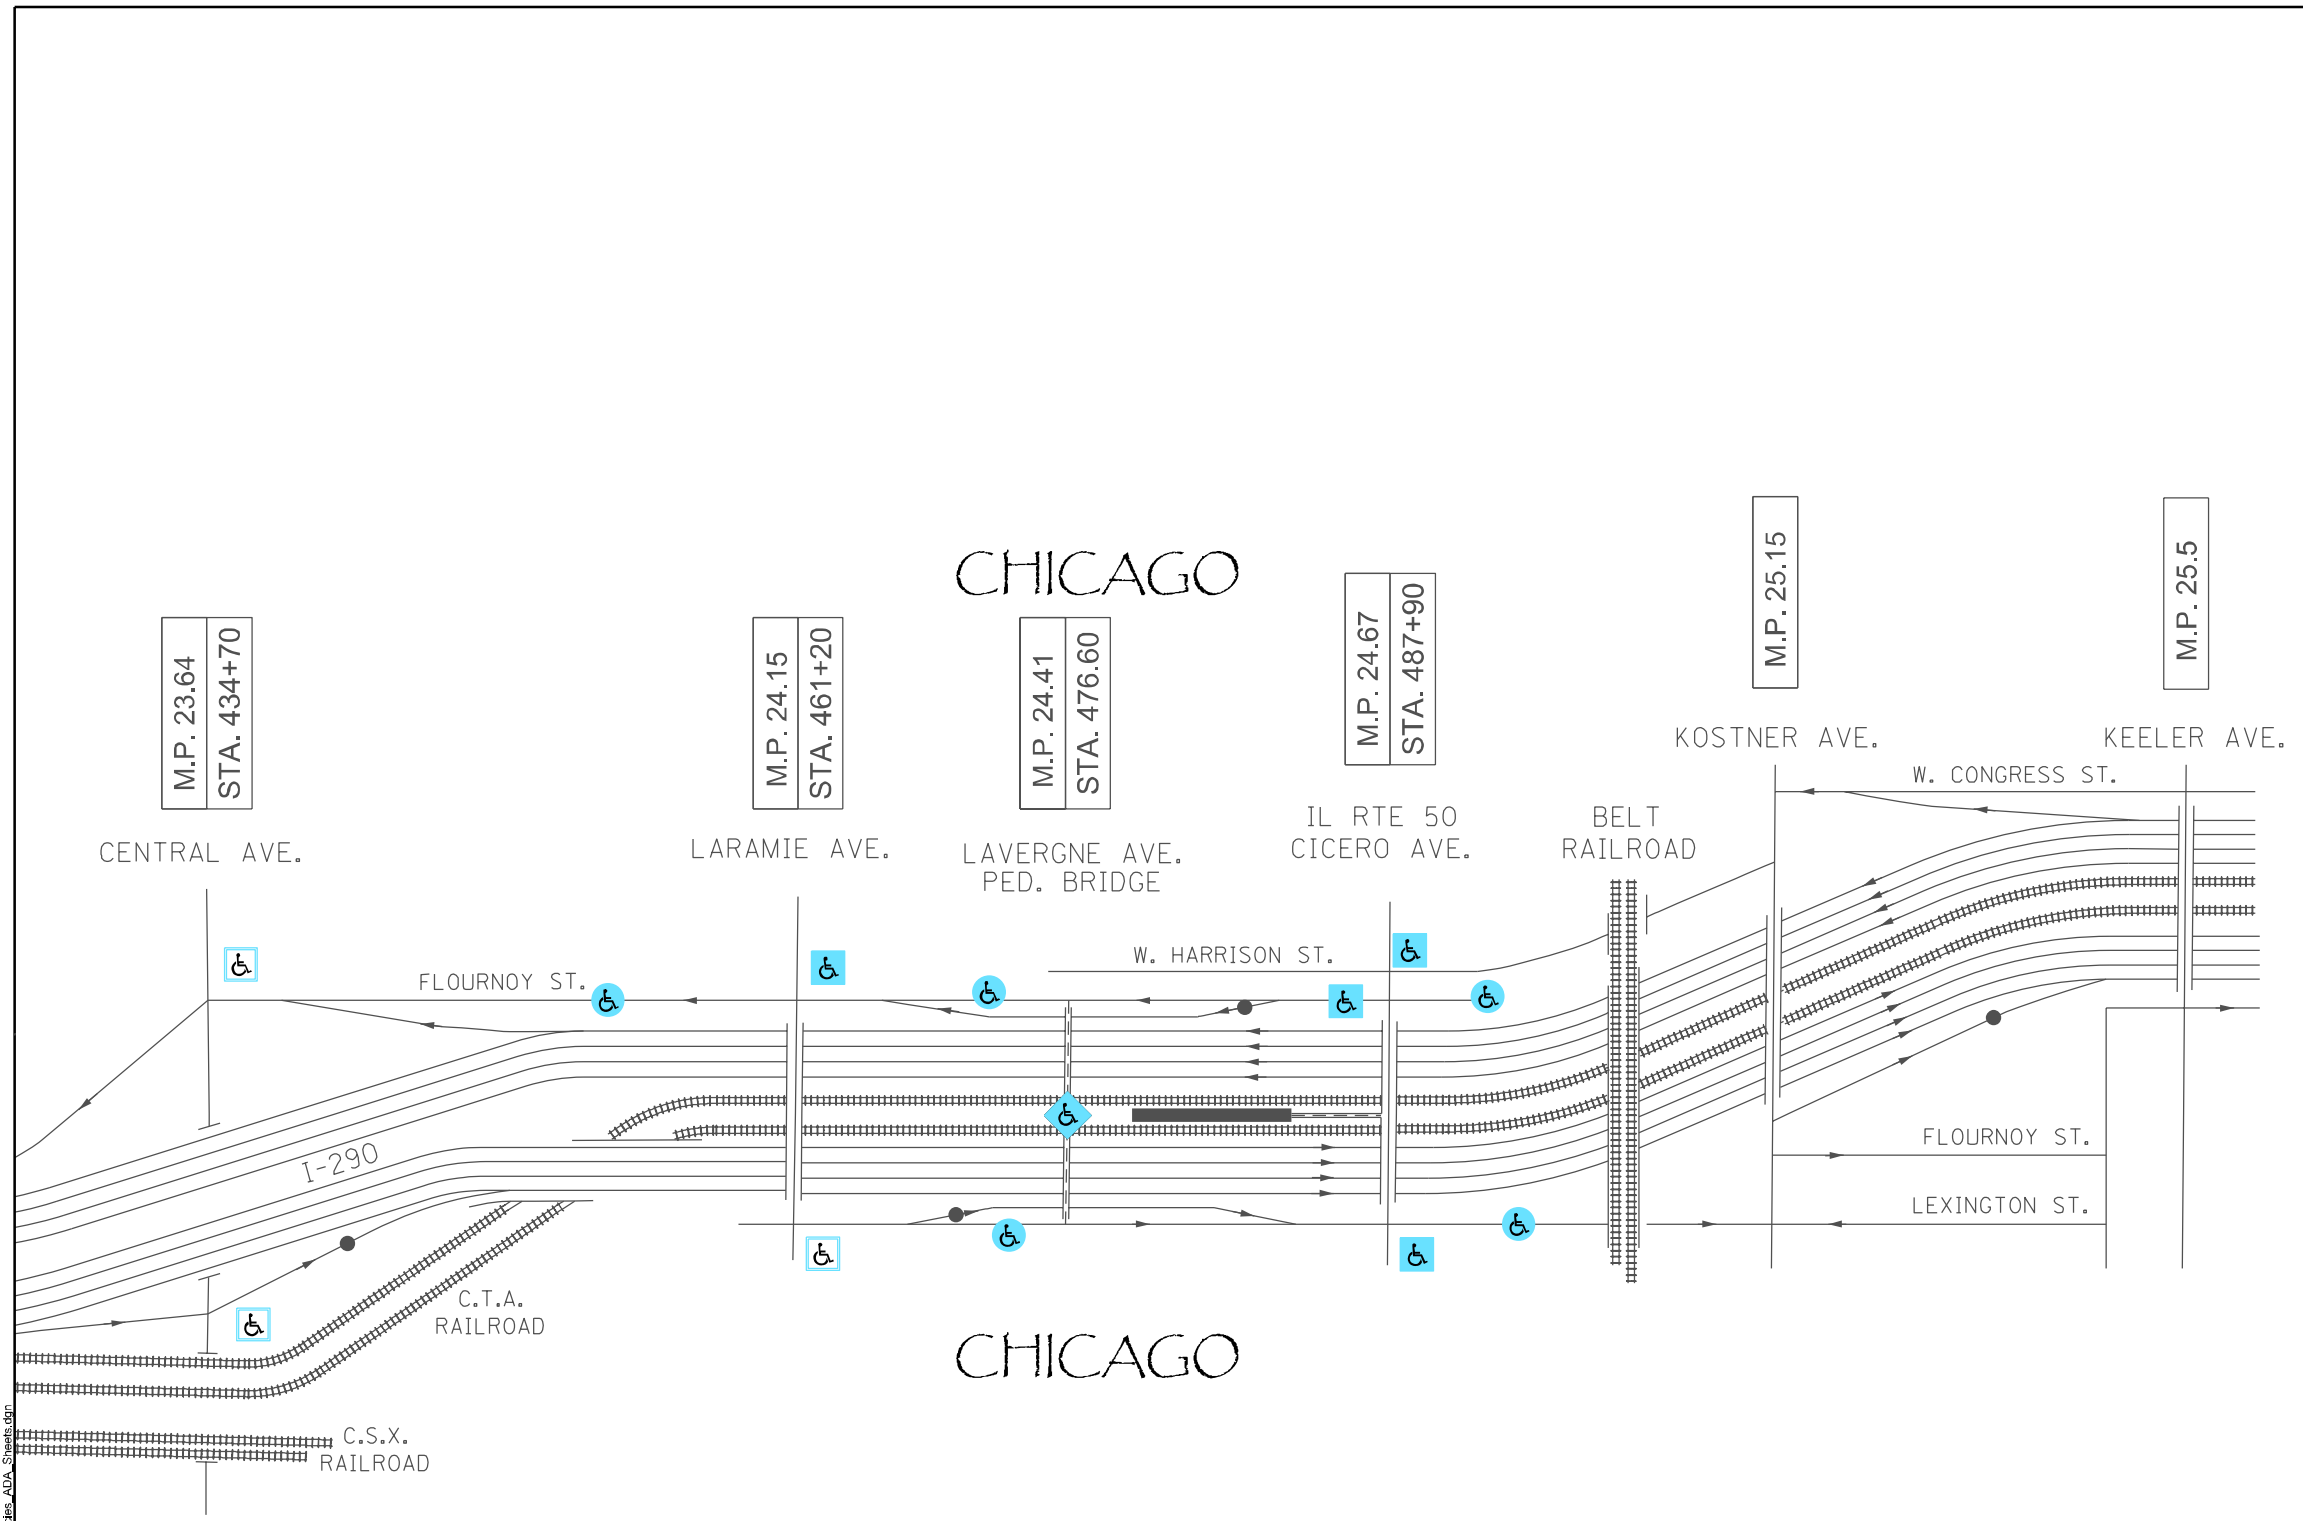
I-290 EXISTING ADA ACCESSIBILITY DIAGRAM
3 OF 4

ADA DEFICIENCIES LEGEND	
CROSSROAD	FRONTAGE RD.
	ADA Route - Not Compliant
	ADA Route - Not Desirable
	ADA Curb Ramp - Not Compliant
	ADA Curb Ramp - Not Desirable

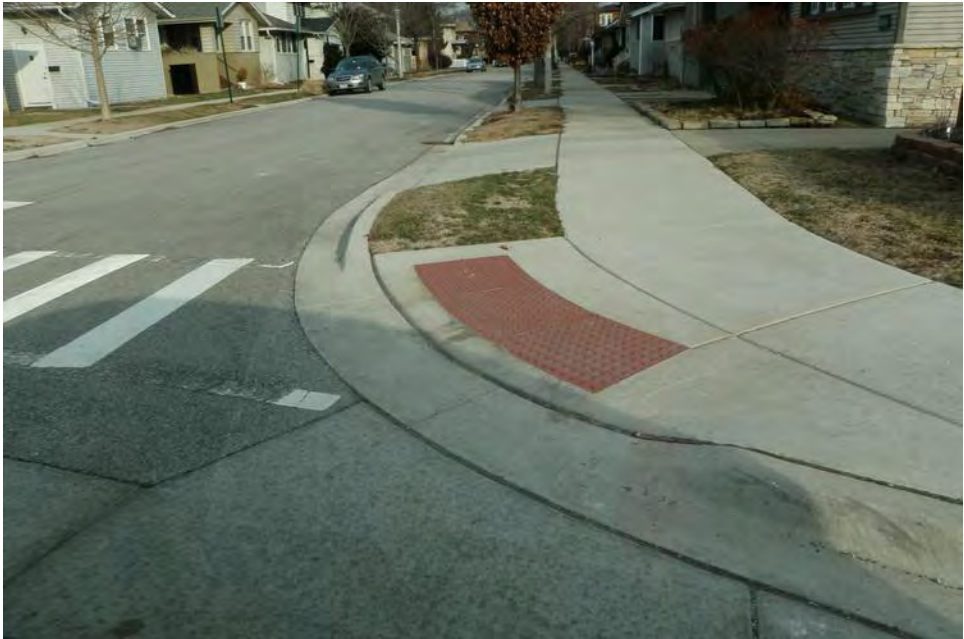
Clarence/Garfield	SW	Frontage Road	242	Fair	Not Desirable	Repair	Old	Update Detectable Warning
Clarence/Garfield	SE	Frontage Road	243	Fair	Not Desirable	Repair	Old	Update Detectable Warning
Southeast/Lexington	NW	Crossroad	244	Fair	Not Desirable	Repair	Old	Update Detectable Warning
Southeast/Lexington	NW	Crossroad	245	Fair	Not Desirable	Repair	Old	Update Detectable Warning
Southeast/Lexington	SW	Crossroad	246	Fair	Not Desirable	Repair	Old	Update Detectable Warning
Southeast/Lexington	SW	Crossroad	247	Fair	Not Desirable	Repair	Old	Update Detectable Warning
Southeast/Lexington	SE	Crossroad	248	Fair	Not Desirable	Repair	Old	Update Detectable Warning
Southeast/Lexington	NE	Crossroad	249	Fair	Not Desirable	Repair	Old	Update Detectable Warning
Southeast/Garfield	SW	Crossroad	250	Good	Yes	-	Yes	
Southeast/Garfield	NW	Crossroad	251	Poor	No	Repair	No	Add Detectable Warning
Southeast/Garfield	SE	Crossroad	252	Good	Yes	-	Yes

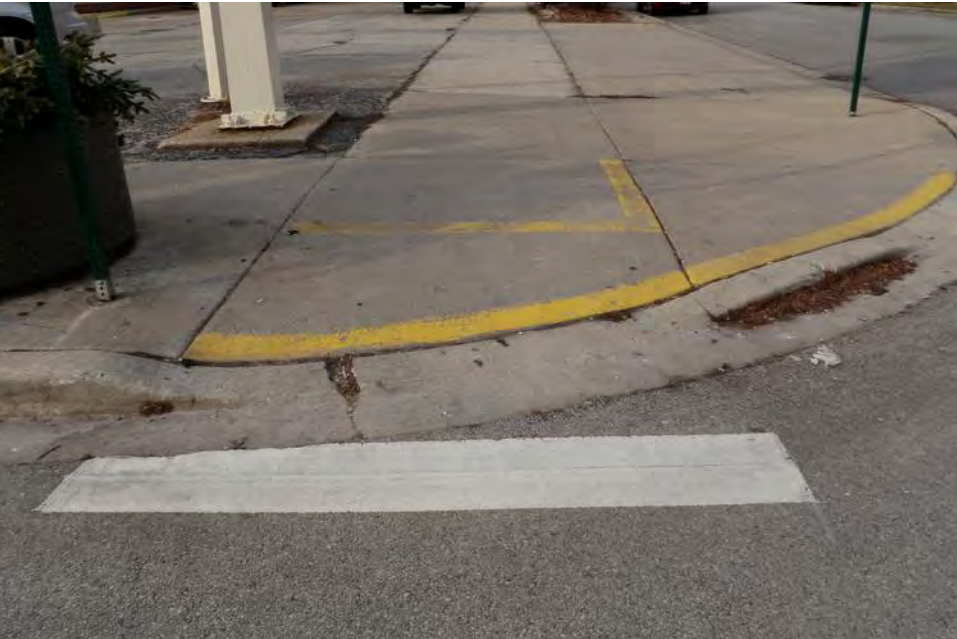
Southeast/Garfield	NE	Crossroad	253	Poor	Yes	Repair	Yes	Repair sidewalk on bridge
Driveway Entrance East of Southeast/Garfield	SW	Frontage Road	254	Fair	No	Repair	No	Add Detectable Warning
Driveway Entrance East of Southeast/Garfield	SE	Frontage Road	255	Fair	No	Repair	No	Add Detectable Warning
Driveway Entrance West of Gunderson/Garfield	SW	Frontage Road	256	Fair	No	Redesign	No	Add Detectable Warning
Driveway Entrance West of Gunderson/Garfield	SE	Frontage Road	257	Fair	No	Redesign	No	Add Detectable Warning
Gunderson/Garfield	SW	Frontage Road	258	Good	Yes	-	Yes	
Gunderson/Garfield	SE	Frontage Road	259	Good	Yes	-	Yes	
Alley East of Gunderson/Garfield	SE	Frontage Road	260	Fair	No	Redesign	No	Sidewalk width with pole, add det. warning
Elmwood/Garfield	SW	Frontage Road	261	Fair	No	Repair	No	Add Detectable Warning
Elmwood/Garfield	SE	Frontage Road	262	Fair	No	Repair	No	Add Detectable Warning
Alley East of Elmwood/Garfield	SW	Frontage Road	263	Poor	No	Redesign	No	Add Detectable Warning

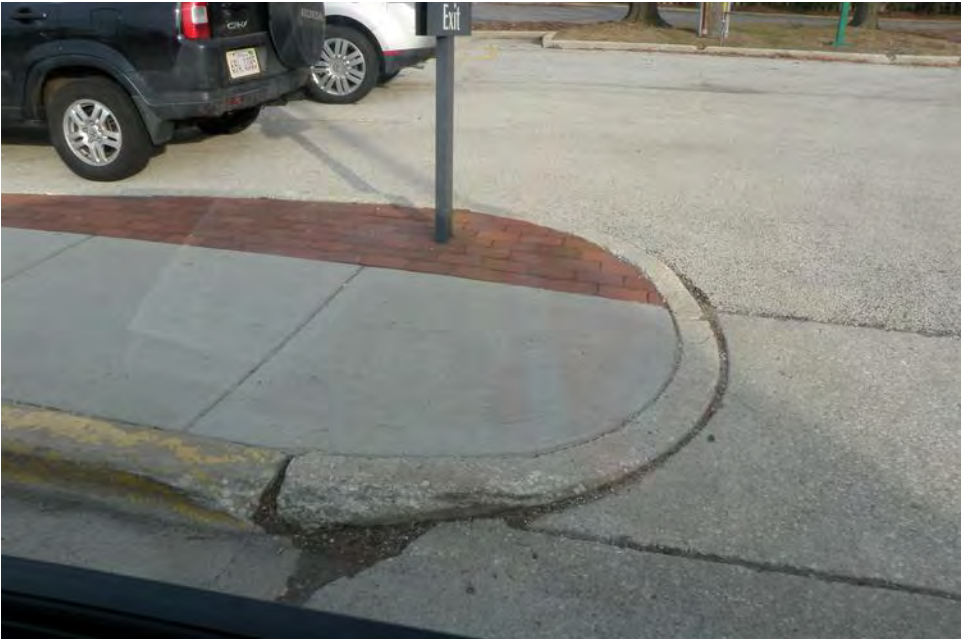
Alley East of Elmwood/Garfield	SE	Frontage Road	264	Fair	No	Redesign	No	Add Detectable Warning
Ridgeland/Garfield	SW	Crossroad	265	Good	Yes	-	Yes	
Ridgeland/Garfield	NW	Crossroad	266	Good	Yes	-	Yes	
Ridgeland/Garfield	NE	Crossroad	267	Good	Yes	-	Yes	
Ridgeland/Garfield	NE	Crossroad	268	Good	Yes	-	Yes	
Ridgeland/Garfield	SE	Crossroad	269	Good	Yes	-	Yes	
Alley South of Garfield/Ridgeland	NW	Crossroad	270	Good	Yes	-	Yes	
Alley South of Garfield/Ridgeland	NW	Crossroad	271	Fair	Not Desirable	Repair	Old	Update Detectable Warning
Alley South of Garfield/Ridgeland	SW	Crossroad	272	Fair	Not Desirable	Repair	Old	Update Detectable Warning
Cuyler/Garfield	SW	Frontage Road	273	Fair	No	Repair	No	Add Detectable Warning
Cuyler/Garfield	SW	Frontage Road	274	Fair	No	Repair	No	Add Detectable Warning
Cuyler/Garfield	SE	Frontage Road	275	Fair	No	Repair	No	Add Detectable Warning

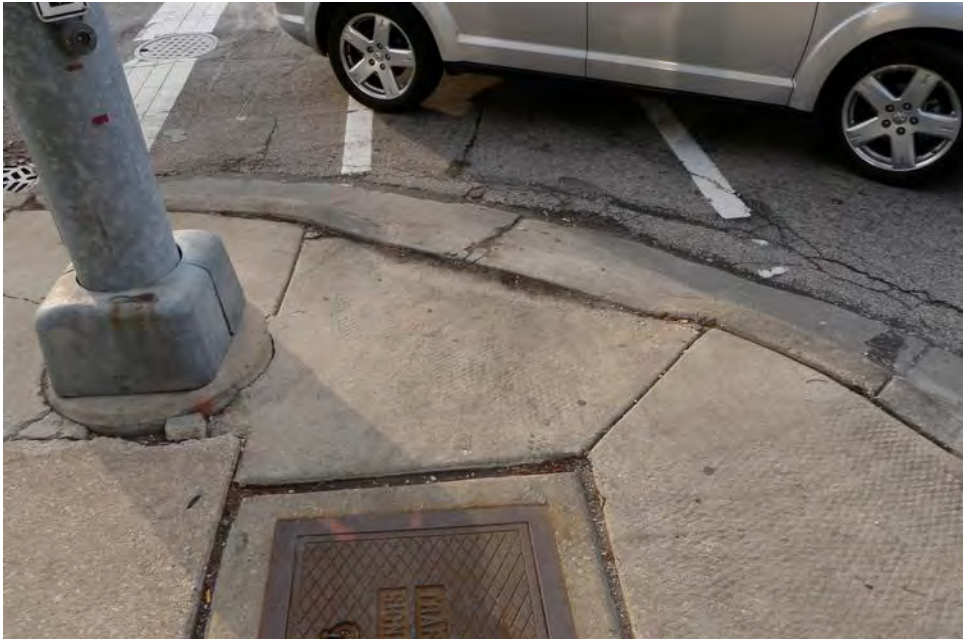
Driveway South Nursing Center at Railroad/Austin	SE	Crossroad	311	Fair	No	Redesign	No	Add Detectable Warning
Driveway South Nursing Center at Railroad/Austin	NE	Crossroad	312	Fair	No	Repair	No	Add Detectable Warning
South Nursing Center Entrance South of Railroad/Austin	SE	Crossroad	313	Fair	No	Repair	No	Add Detectable Warning
South Nursing Center Entrance South of Railroad/Austin	NE	Crossroad	314	Fair	No	Repair	No	Add Detectable Warning
North Nursing Center Entrance South of Railroad/Austin	SE	Crossroad	315	Fair	No	Repair	No	Add Detectable Warning
North Nursing Center Entrance South of Railroad/Austin	NE	Crossroad	316	Fair	No	Repair	No	Add Detectable Warning
Austin/Harvard/Arthington	NW	Crossroad	317	Fair	No	Repair	No	Add Detectable Warning
Austin/Harvard/Arthington	NW	Crossroad	318	Good	Yes	-	Yes	
Austin/Harvard/Arthington	SW	Crossroad	319	Good	Yes	-	Yes	
Austin/Harvard/Arthington	SE	Crossroad	320	Fair	Not Desirable	Repair	Old	Update Detectable Warning

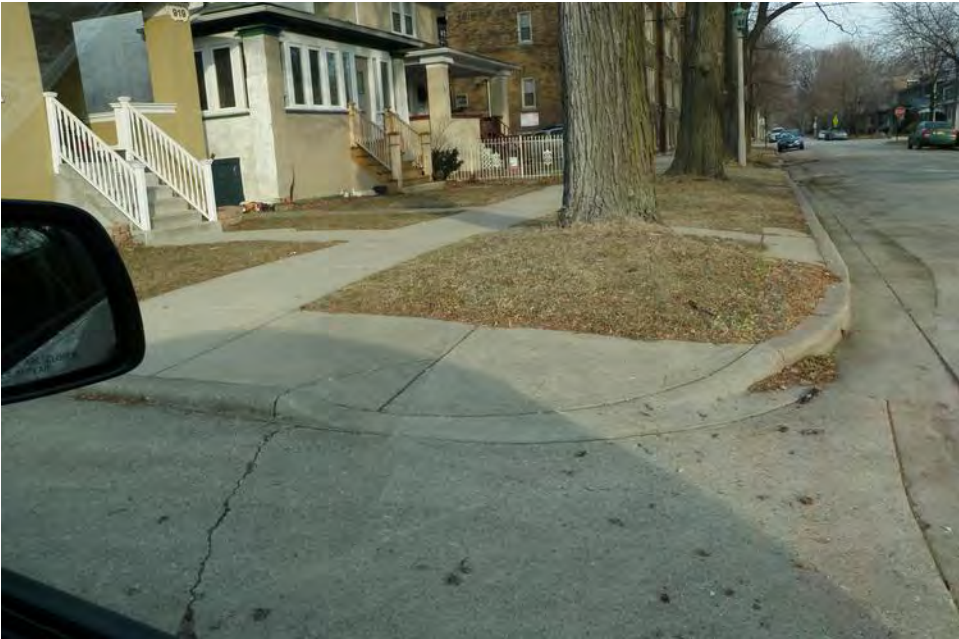
Austin/Harvard/Arthington	NE	Crossroad	321	Fair	No	Repair	No	Add Detectable Warning
Austin/Harvard/Arthington	NE	Crossroad	322	Fair	No	Repair	No	Add Detectable Warning
Mason/Railroad	SW	Frontage Road	323	Good	Yes	-	Yes	
Mason/Railroad	SE	Frontage Road	324	Good	Yes	-	Yes	
Alley East of Mason/Railroad	SW	Frontage Road	325	Good	Yes	-	Yes	
Alley East of Mason/Railroad	SE	Frontage Road	326	Good	Yes	-	Yes	
Mayfield/Railroad	SW	Frontage Road	327	Good	Yes	-	Yes	
Mayfield/Railroad	SE	Frontage Road	328	Good	Yes	-	Yes	
Monitor/Railroad	SW	Frontage Road	329	Good	Yes	-	Yes	
Monitor/Railroad	SE	Frontage Road	330	Good	Yes	-	Yes

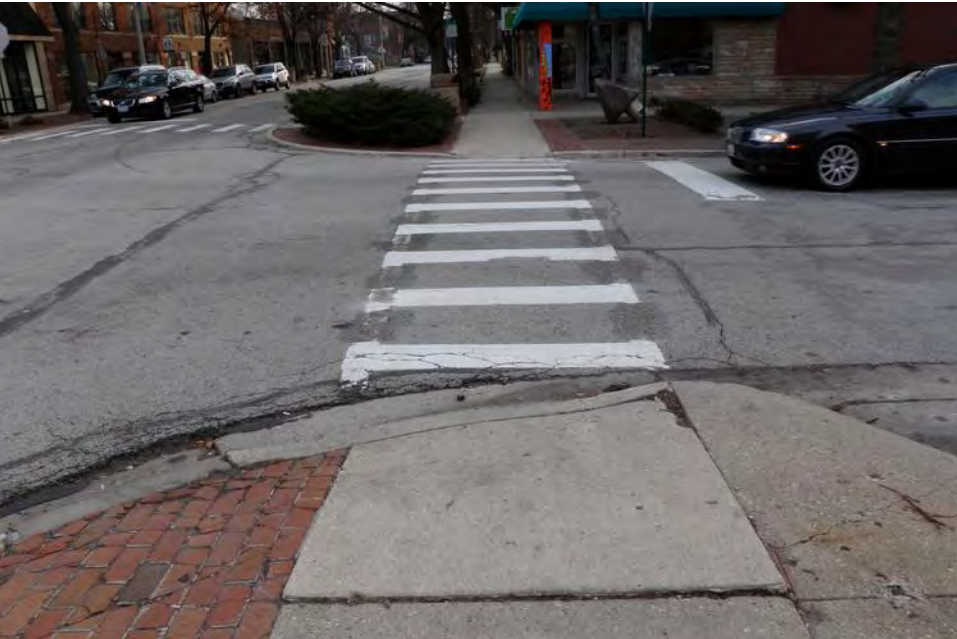
Intersection/Road	Corner	Crossroad/Frontage Road	Picture #	Condition	ADA Compliant	Redesign/Repair	Detectable Warning	Notes
Menard/Railroad	SW	Frontage Road	331	Good	Yes	-	Yes	
Learnington/Lexington	SW	Frontage Road	332	Fair	No	Repair	No	Add Detectable Warning
Learnington/Lexington	SE	Frontage Road	333	Poor	No	Repair	No	Add Detectable Warning
Lavergne/Lexington	SW	Frontage Road	334	Fair	Not Desirable	Repair	Old	Update Detectable Warning
Lavergne/Lexington	SE	Frontage Road	335	Fair	Not Desirable	Repair	Old	Update Detectable Warning
Pedestrian Bridge Lavergne/Lexington	NE	Frontage Road	336	Poor	No	Redesign	No	Add Detectable Warning
Pedestrian Bridge Lavergne/Lexington	NE	Frontage Road	337	Poor	No	Redesign	No	Add Detectable Warning
Pedestrian Bridge Lavergne/Lexington	NE	Frontage Road	338	Poor	No	Redesign	No	Add Detectable Warning
Pedestrian Bridge Lavergne/Lexington	NW	Frontage Road	339	Poor	No	Redesign	No	Add Detectable Warning

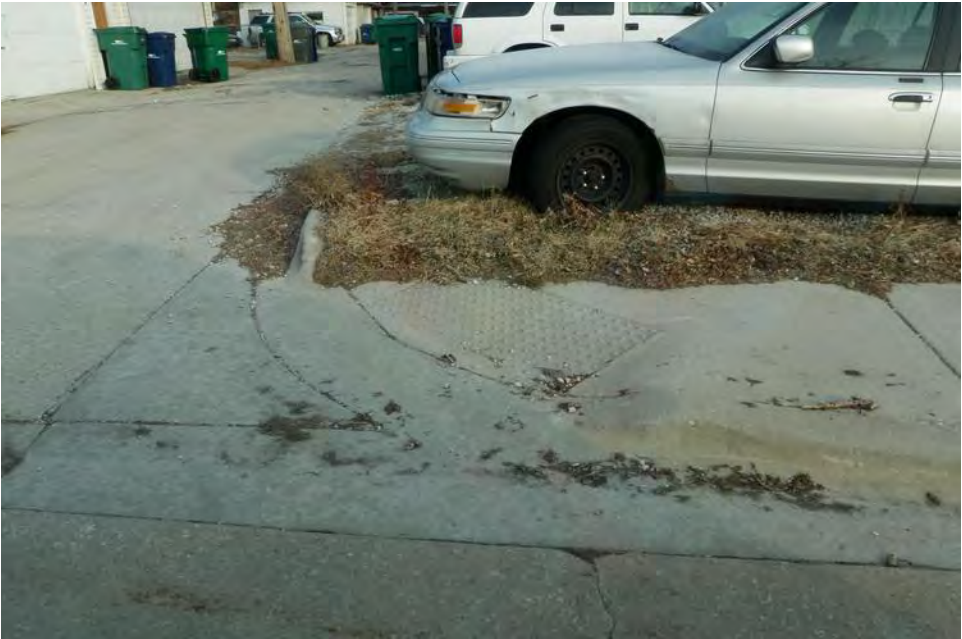
Pedestrian Bridge Lavergne/Lexington	NW	Frontage Road	340	Poor	No	Redesign	No	Add Detectable Warning
Pedestrian Bridge Lavergne/Lexington	NW	Frontage Road	341	Poor	No	Redesign	No	Add Detectable Warning
Alley West of Cicero/Lexington	SW/SE	Frontage Road	342	Poor	No	Repair	No	Add Detectable Warning
Cicero/Lexington	NW	Crossroad	343	Poor	No	Redesign	No	Add Detectable Warning
Cicero/Lexington	SW	Crossroad	344	Fair	Not Desirable	Repair	Old	Update Detectable Warning
Cicero/Lexington	SE	Crossroad	345	Poor	No	Redesign	No	Add Detectable Warning
Cicero/Lexington	SE	Crossroad	346	Poor	No	Redesign	No	Add Detectable Warning
Cicero/Lexington	NE	Crossroad	347	Poor	No	Redesign	No	Add Detectable Warning
Cicero/Polk	NE	Crossroad	348	Poor	Not Desirable	Repair	Old	Update Detectable Warning
Cicero/Polk	NE	Crossroad	349	Fair	Not Desirable	Repair	Old	Update Detectable Warning
Cicero/Polk	NW	Crossroad	350	Fair	Not Desirable	Repair	Old	Update Detectable Warning

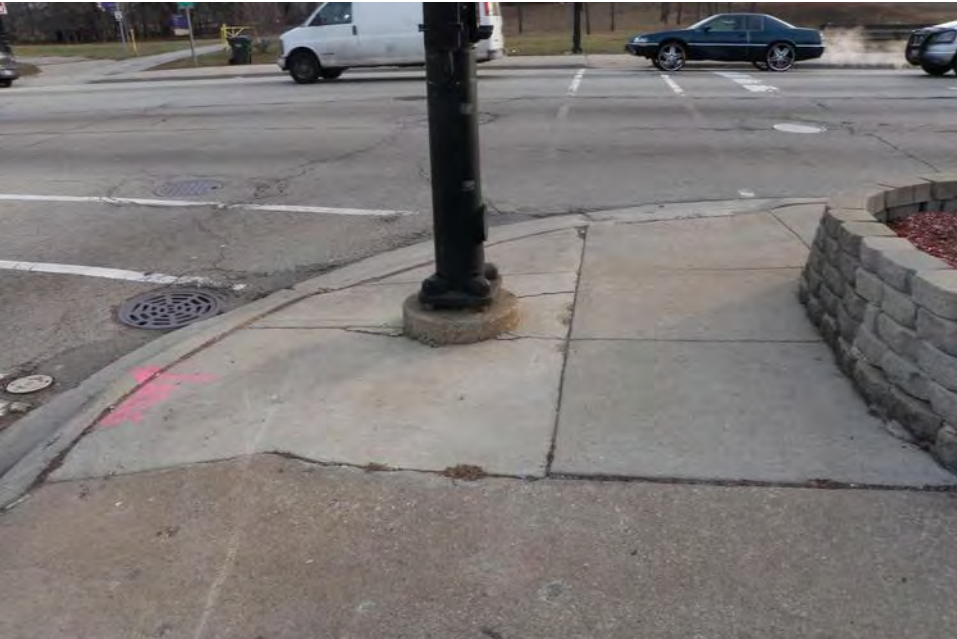
Cicero/Polk	SW	Crossroad	351	Fair	Not Desirable	Repair	Old	Update Detectable Warning
Alley East of Cicero/Polk	SW	Frontage Road	352	Fair	No	Redesign	No	Add Detectable Warning
Alley East of Cicero/Polk	SE	Frontage Road	353	Fair	No	Redesign	No	Add Detectable Warning
Kilpatrick/Lexington	SW	Frontage Road	354	Poor	No	Redesign	No	Sidewalk slope, add detectable warning
Kilpatrick/Lexington	SE	Frontage Road	355	Good	Yes	-	Yes	
Alley East of Kilpatrick/Lexington	SW	Frontage Road	356	Poor	No	Redesign	No	Add Detectable Warning
Alley East of Kilpatrick/Lexington	SE	Frontage Road	357	Poor	No	Redesign	No	Add Detectable Warning
Kolmar/Lexington	SW	Frontage Road	358	Good	Yes	-	Yes	
Kolmar/Lexington	SE	Frontage Road	359	Good	Yes	-	Yes	
Kilbourn/Lexington	SW	Frontage Road	360	Good	Yes	-	Yes	
Kilbourn/Lexington	SE	Frontage Road	361	Good	Yes	-	Yes

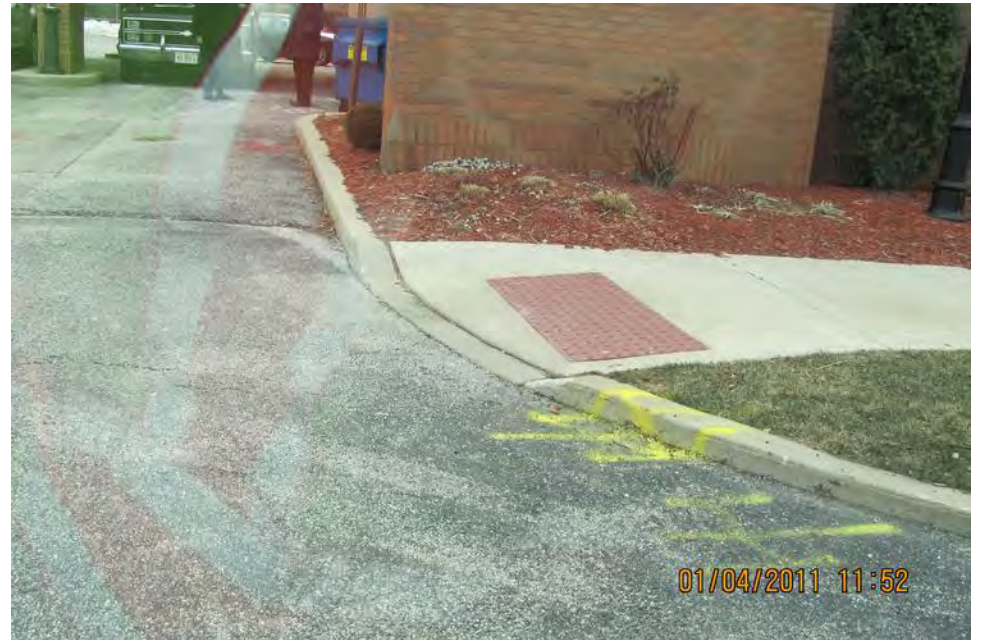
Intersection/Road	Corner	Crossroad/Frontage Road	Picture #	Condition	ADA Compliant	Redesign/Repair	Detectable Warning	Notes
Wolf/Jackson	NW	Crossroad	1	Fair	Not Desirable	Redesign	Old	Update Detectable Warning
Wolf/Jackson	SW	Crossroad	2	Fair	No	Repair	No	Add Detectable Warning
Wolf/Jackson	SE	Crossroad	3	Fair	Not Desirable	Repair	Old	Update Detectable Warning
Wolf/Jackson	NE	Crossroad	4	Fair	Not Desirable	Repair	Old	Update Detectable Warning
Iroquois/Jackson	NW	Frontage Road	5	Fair	Not Desirable	Repair	Old	Update Detectable Warning
Iroquois/Jackson	NE	Frontage Road	6	Good	Yes	-	Yes	
Jackson/Frontage Road	NW	Frontage Road	7	Fair	Not Desirable	Repair	Old	Update Detectable Warning
Jackson/Frontage Road	NE	Frontage Road	8	Fair	Not Desirable	Repair	Old	Update Detectable Warning
Frontage Road/Underpass	NW	Crossroad	9	Fair	Not Desirable	Repair	Old	Update Detectable Warning
Frontage Road/Underpass	SW	Crossroad	10	Fair	Not Desirable	Repair	Old	Update Detectable Warning
