Technical Memorandum

I-290

Preliminary Engineering

Existing Americans with Disabilities Act (ADA) Accessibility

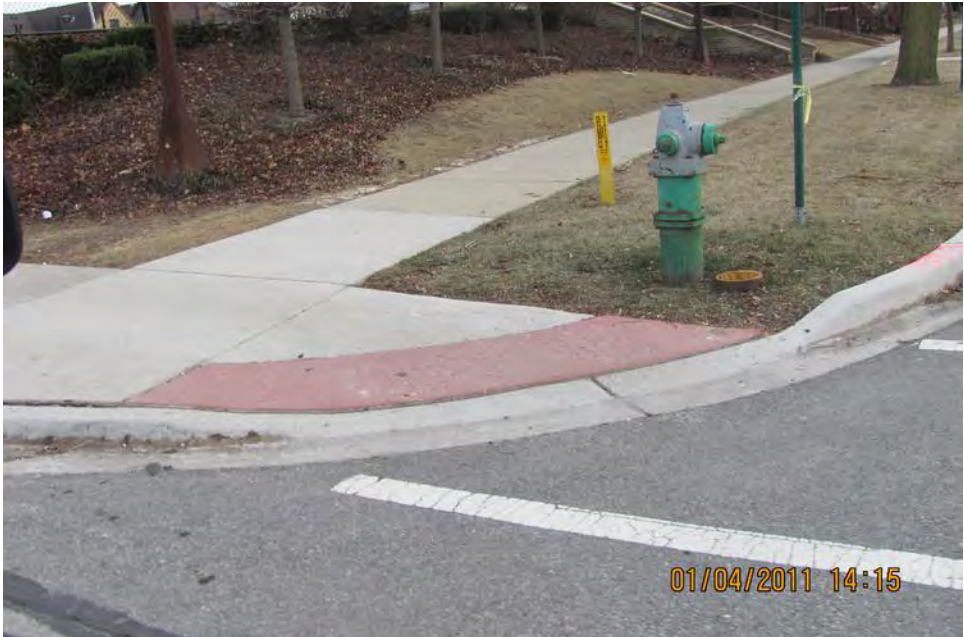
Intersection/Road	Corner	Crossroad/Frontage Road	Picture #	Condition	ADA Compliant	Redesign/Repair	Detectable Warning	Notes
Cuyler/Garfield	SE	Frontage Road	276	Fair	No	Repair	No	Add Detectable Warning
Alley East of Cuyler/Garfield	SW	Frontage Road	277	Fair	No	Redesign	No	Add Detectable Warning
Alley East of Cuyler/Garfield	SE	Frontage Road	278	Fair	No	Redesign	No	Add Detectable Warning
Highland/Garfield	SW	Frontage Road	279	Fair	No	Redesign	No	Sidewalk slope, add detectable warning
Highland/Garfield	SE	Frontage Road	280	Fair	No	Repair	No	Add Detectable Warning
Alley East of Highland/Garfield	SW	Frontage Road	281	Fair	No	Redesign	No	Add Detectable Warning
Alley East of Highland/Garfield	SE	Frontage Road	282	Fair	No	Redesign	No	Add Detectable Warning
Harvey/Garfield	SW	Frontage Road	283	Good	Yes	-	Yes	
Harvey/Garfield	SE	Frontage Road	284	Good	Yes	-	Yes	
Lombard/Garfield	SW	Crossroad	285	Good	Yes	-	Yes

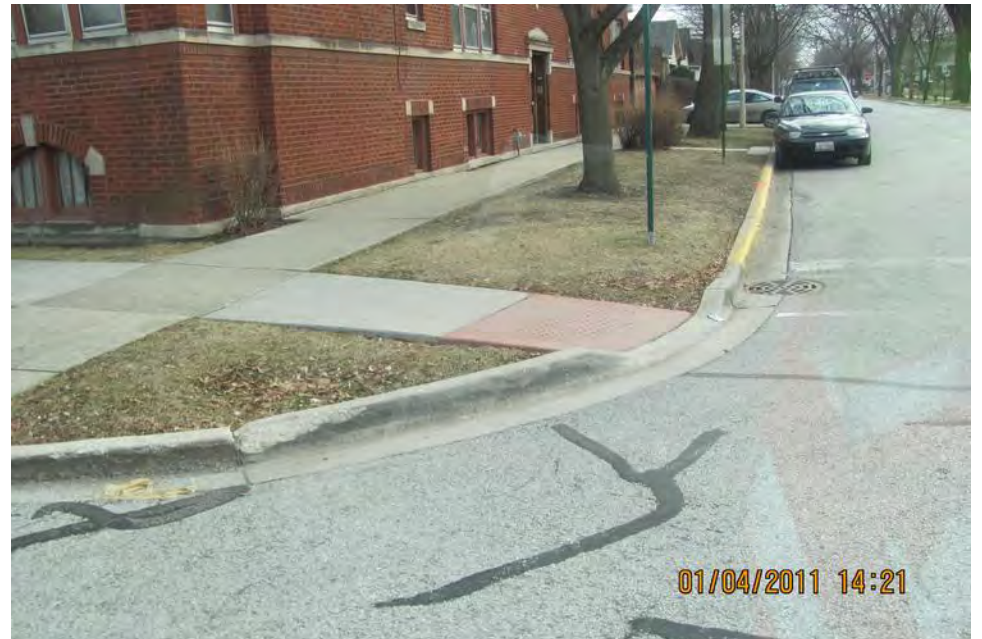
Humphrey/Garfield	SE	Frontage Road	300	Good	Yes	-	Yes	
Humphrey/Garfield	SE	Frontage Road	301	Fair	No	Repair	No	Add Detectable Warning
Austin/Garfield/Railroad	SW	Crossroad	302	Fair	No	Repair	No	Add Detectable Warning
Austin/Garfield/Railroad	SW	Crossroad	303	Fair	No	Redesign	No	Sidewalk slope, add detectable warning
Austin/Garfield/Railroad	NW	Crossroad	304	Fair	No	Repair	No	Add Detectable Warning
Austin/Garfield/Railroad	NW	Crossroad	305	Fair	Not Desirable	Repair	Old	Update Detectable Warning
Austin Bridge	Westside	Crossroad	306	Fair	Yes	-	N/A	
Austin/Garfield/Railroad	SE	Crossroad	307	Fair	No	Redesign	No	Add Detectable Warning
Austin/Garfield/Railroad	NE	Crossroad	308	Fair	No	Redesign	No	Sidewalk slope, add detectable warning
Alley South of Garfield/Austin	NW	Crossroad	309	Fair	No	Repair	No	Add Detectable Warning
Alley South of Garfield/Austin	SW	Crossroad	310	Fair	No	Repair	No	Add Detectable Warning

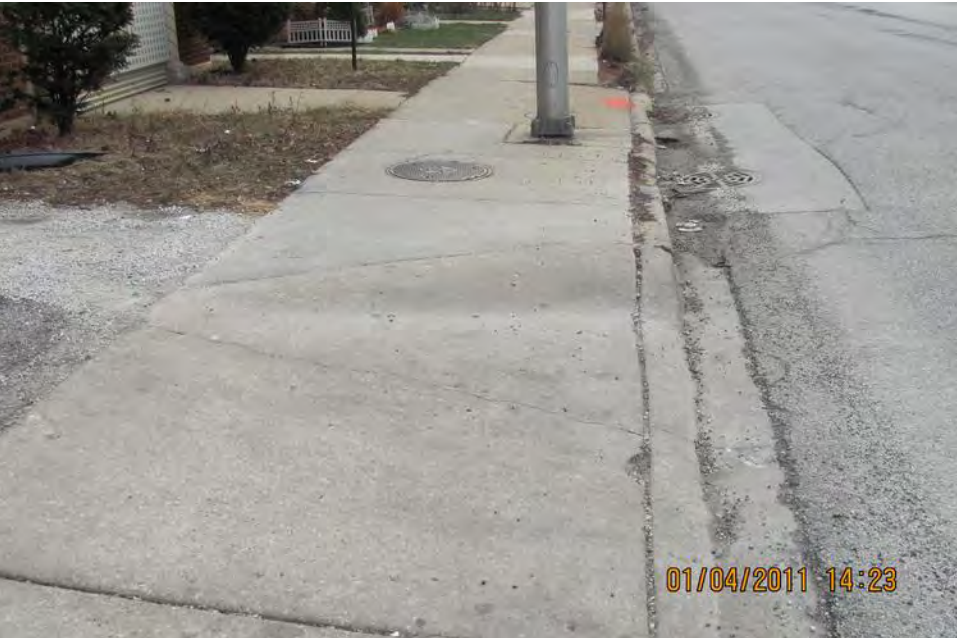
Driveway South Nursing Center at Railroad/Austin	SE	Crossroad	311	Fair	No	Redesign	No	Add Detectable Warning
Driveway South Nursing Center at Railroad/Austin	NE	Crossroad	312	Fair	No	Repair	No	Add Detectable Warning
South Nursing Center Entrance South of Railroad/Austin	SE	Crossroad	313	Fair	No	Repair	No	Add Detectable Warning
South Nursing Center Entrance South of Railroad/Austin	NE	Crossroad	314	Fair	No	Repair	No	Add Detectable Warning
North Nursing Center Entrance South of Railroad/Austin	SE	Crossroad	315	Fair	No	Repair	No	Add Detectable Warning
North Nursing Center Entrance South of Railroad/Austin	NE	Crossroad	316	Fair	No	Repair	No	Add Detectable Warning
Austin/Harvard/Arthington	NW	Crossroad	317	Fair	No	Repair	No	Add Detectable Warning
Austin/Harvard/Arthington	NW	Crossroad	318	Good	Yes	-	Yes	
Austin/Harvard/Arthington	SW	Crossroad	319	Good	Yes	-	Yes	
Austin/Harvard/Arthington	SE	Crossroad	320	Fair	Not Desirable	Repair	Old	Update Detectable Warning

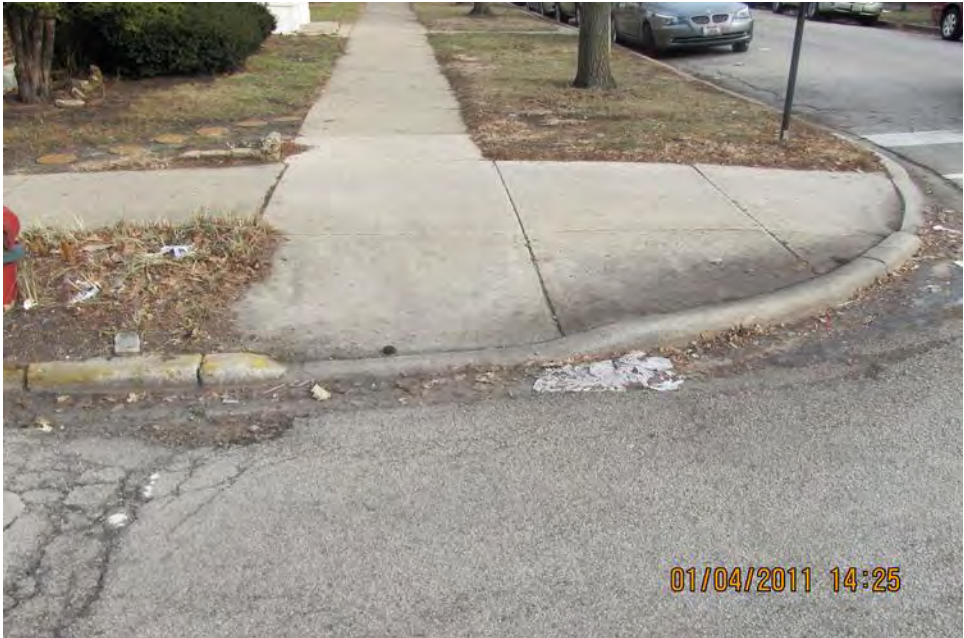
Austin/Harvard/Arthington	NE	Crossroad	321	Fair	No	Repair	No	Add Detectable Warning
Austin/Harvard/Arthington	NE	Crossroad	322	Fair	No	Repair	No	Add Detectable Warning
Mason/Railroad	SW	Frontage Road	323	Good	Yes	-	Yes	
Mason/Railroad	SE	Frontage Road	324	Good	Yes	-	Yes	
Alley East of Mason/Railroad	SW	Frontage Road	325	Good	Yes	-	Yes	
Alley East of Mason/Railroad	SE	Frontage Road	326	Good	Yes	-	Yes	
Mayfield/Railroad	SW	Frontage Road	327	Good	Yes	-	Yes	
Mayfield/Railroad	SE	Frontage Road	328	Good	Yes	-	Yes	
Monitor/Railroad	SW	Frontage Road	329	Good	Yes	-	Yes	
Monitor/Railroad	SE	Frontage Road	330	Good	Yes	-	Yes
